**Flood Control Project Maintenance
Levee Inspections**
LMA District Cover Sheet
Spring 2009 Levee Inspection Results

Reclamation District No. 0307

**Flood Control Project Maintenance
Levee Inspections
Unit Cover Sheet
Spring 2009 Levee Inspection Results
Reclamation District No. 0307**

Levee Inspection Report By Mile - Spring 2009

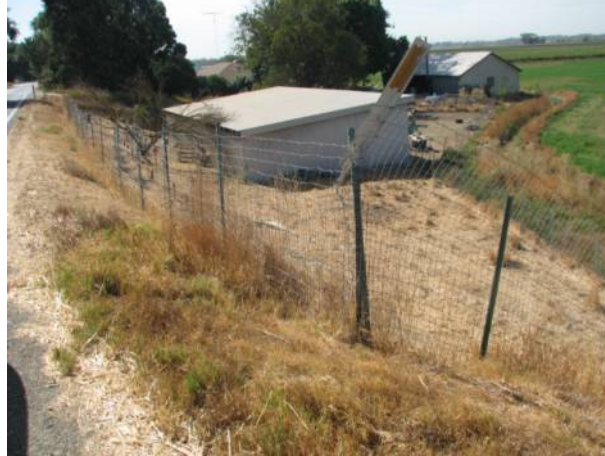
| Levee Mile Report Line | 30 |

| LMR Line | Levee Mile | | Category | Item | Location | Rating | Action/Comment | GPS Latitude/Longitude | | Photo | Issue |
|---|---|---|---|---|---|---|---|---|---|---|---|
| 30 | 2.99 | 3.03 | Earthen Levee | Encroachments | LS | PO | Fences Inspector Comments: Photo has been added to report to show the encroachment. The land owner has goats inside this fence area. There is no need for this fence to be on the levee section. | 38.464055 ° -121.505350 ° | 38.463517 ° -121.505270 ° | Y | 22 |

| unauthorized fence located landward in RD 307. | |

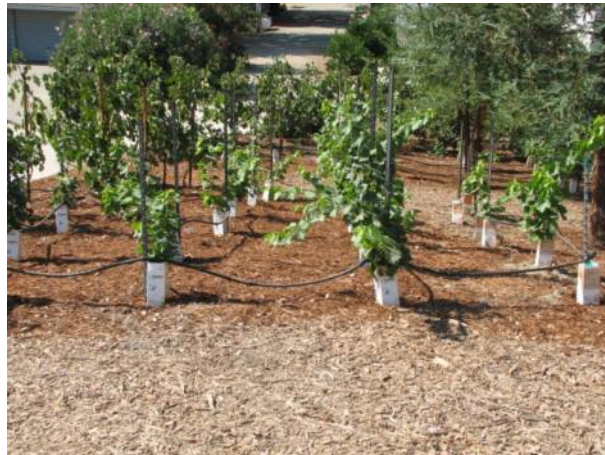
| Levee Mile Report Line | 46 |

| LMR Line | Levee Mile | | Category | Item | Location | Rating | Action/Comment | GPS Latitude/Longitude | | Photo | Issue |
|---|---|---|---|---|---|---|--|---|---|---|---|
| 46 | 4.43 | 4.44 | Earthen Levee | Encroachments | LS | U | Crops | 38.443798 ° -121.503320 ° | 38.443637 ° -121.503323 ° | Y | 79 |

| Unauthorized grapes vinyard with driplines placed within levee shouldr and slope Levee mile 4.5038.443822-121.503262 | |
